Final Report on Snowmaking Pilot Plant Using Treated Wastewater

December 2012

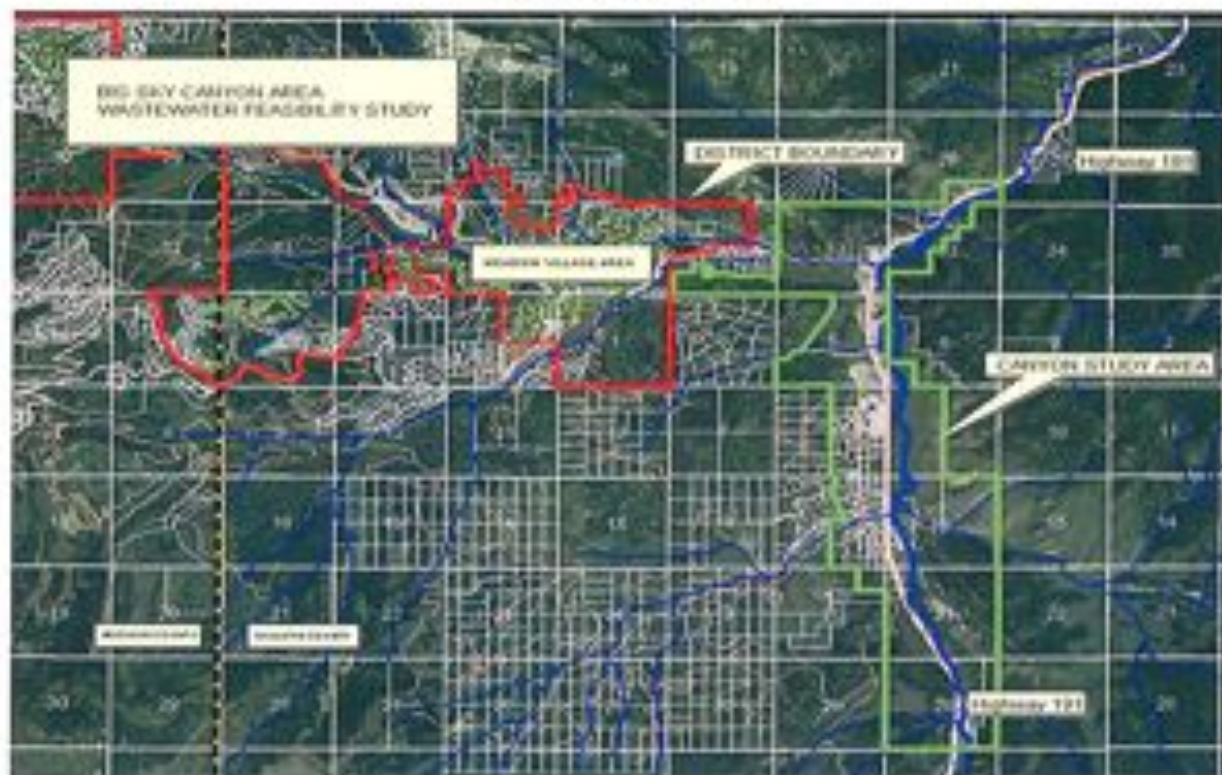
Figure 1
Canyon Study Area

In December of 2001, the Montana Board of Environmental Review (BER) received a petition to designate the Gallatin River as an Outstanding Resource Water (ORW) from the Yellowstone National Park boundary to Spanish Creek, a river reach that would include the Canyon Study area shown in Figure 1. The BER ordered the Montana Department of Environmental Quality to prepare an Environmental Impact Statement (EIS) to disclose the potential impacts of the ORW designation. The Final EIS published in 2007 found that under the proposed action approximately 67 Single Family Equivalent (SFE's) could be built before impacts to water quality from nutrients would be observed (Montana Department of Environmental Quality, 2007). The problem was, and continues to be, that the existing development already exceeds the 67 SFE allowable under the ORW designation.

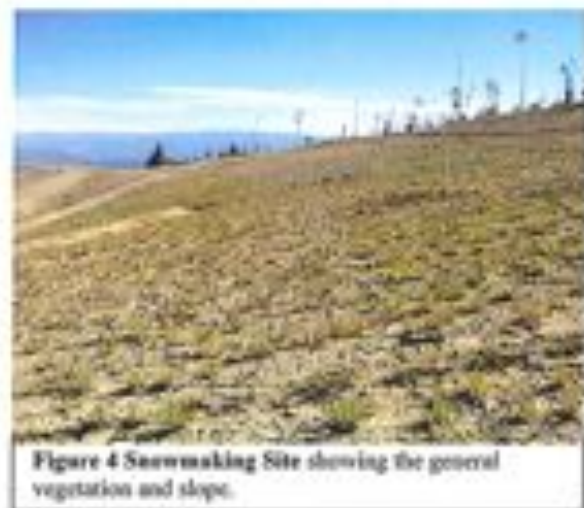
Figure 4 Snowmaking Site showing the general vegetation and slope.

The snowmaking site was located at an elevation of 8270 feet above sea level, on a cut slope created when the effluent storage pond was constructed at the Yellowstone Club. The site slope and vegetation is similar to what would be expected in any future large scale snowmaking operation. Waterbars were constructed at the toe of the snowmaking area to direct any runoff into the storage pond. Figure 3 is an aerial view of the site showing the site modifications that were made to direct runoff to the storage pond and Figure 4 shows the slope and vegetation present.

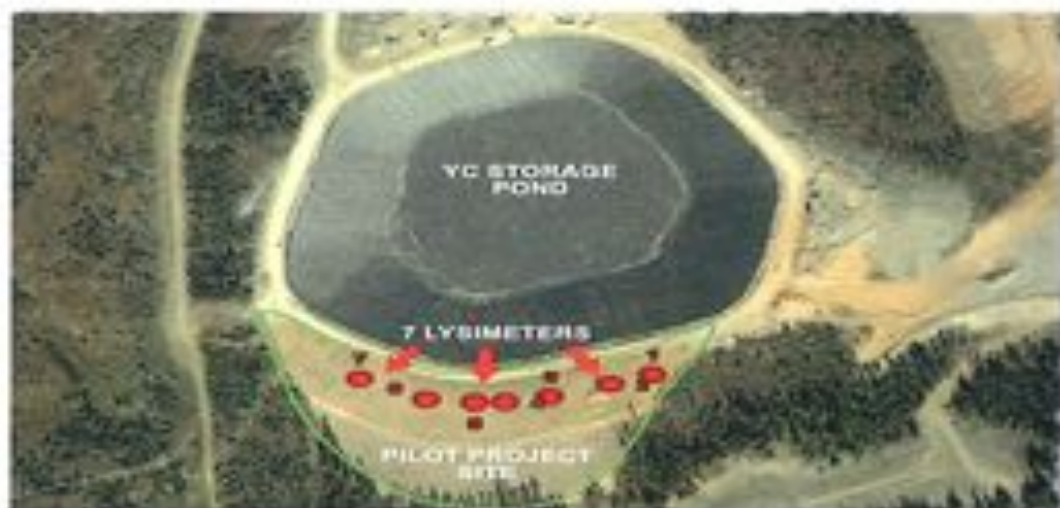
Figure 5- Lysimeter locations

Seven bucket-lysimeters (See attachment 1) were installed along the hillside to collect snowmelt water percolating through the soil (Figure 5). The lysimeters were installed at depths ranging from 2-3 feet below the ground surface.

Soil excavated during the installation was placed inside the lysimeter so snowmelt would percolate through soil layers similar to natural conditions.

Of the 7 lysimeters installed, only 1 collected water during the spring melt which suggests the primary hydrologic pathway during snowmelt is surface runoff.

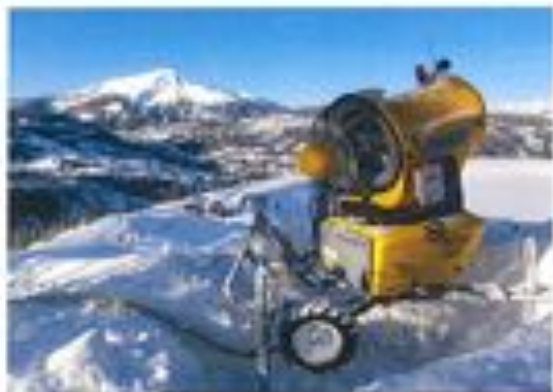
Figure 6 – Snowmaking Gun

inches) with an average of 43.7 cm (17.21 inches) in the six pits dug in January (Appendix A). The spraying operation used a Techno Alpin T-40 snowmaking gun (Figure 6). The snow pile created during the spraying operation was spread over a 3 acres site with a snowcat.

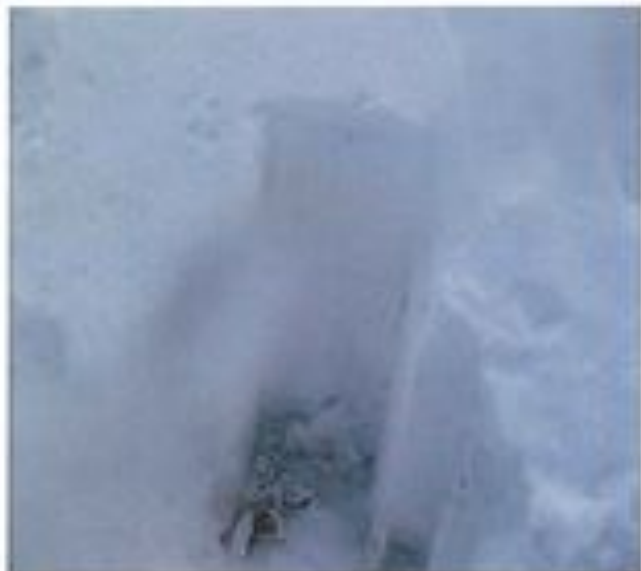
Figure 7 Snow pack sampling pit. Photo of 30 cm x 30 cm excavated column for snowpack sampling. Photo taken by Rich Chandler on 12/2011

After the snowmaking process was completed, snow pack samples were taken monthly. One control sample was taken of natural snow at the same location as the control lysimeter, the western most site. Three separate samples were taken at the same elevation across the slope within the testing boundary. The test elevation was mid slope at locations where the depth of the manmade snow best represented the coverage goal of 45-60 cm. A snow pit (Figure 7) was excavated and a 30 cm by 30 cm snow column was carefully removed and transferred into a plastic bag. Snow density and depth were then recorded. During the December sampling the depth of the control was 25 cm, the first site had a depth of 45 cm, and the second and third sites had depths of 70 & 80 cm respectively. The samples were then taken back to the BSWWS laboratory for melting. Using a hot water bath, the columns were entirely melted before being transferred to bottles. Sulfuric acid was added to one sample bottle for each site to preserve the sample for nitrogen testing. Samples were then shipped overnight to Energy Laboratories in Billings, MT to meet the 24 hour holding time for the Total Coliform/E. Coli parameters.

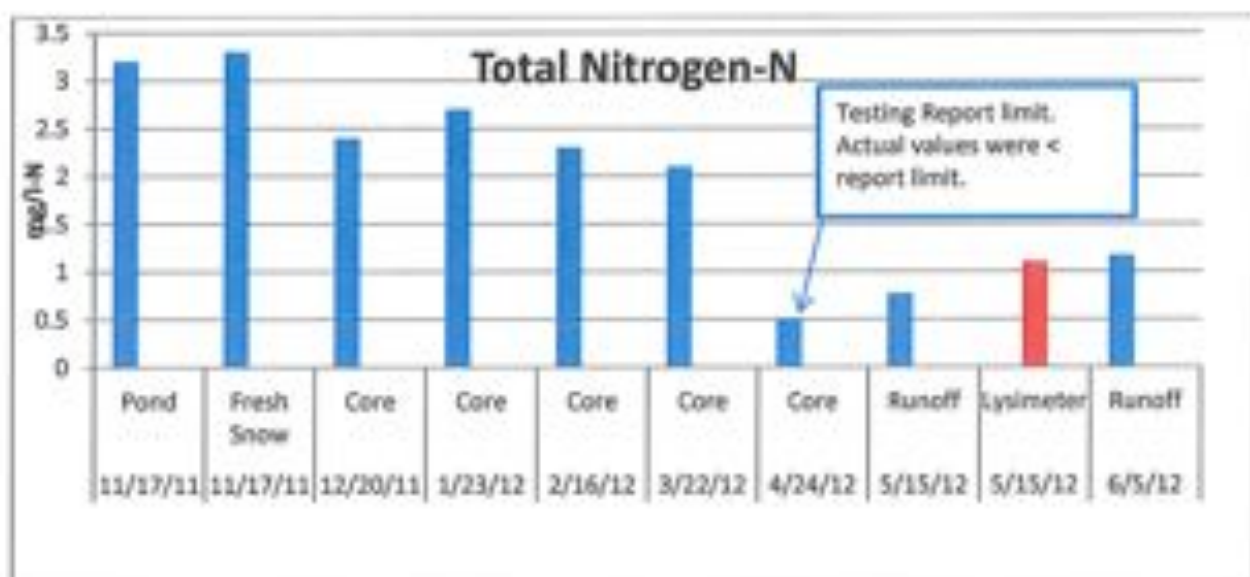
During the winter, total nitrogen levels decreased in the snowpack approximately 69%, from a concentration of 3.2 mg/l in the effluent storage pond and 3.3 mg/l in the sprayed snow to approximately 1.0 mg/l in the runoff water measured in May and June. The core samples collected in April were below the testing report limit of 0.5 mg/l which is at a concentration similar to the control samples. The control samples and samples collected on Pioneer Mountain were below the reporting limits (0.5 mg/l) of the testing method.

The results clearly show that there is a reduction in nitrogen concentration in the ageing snowpack but it is difficult to determine with any accuracy how much of the reduction was due to dilution from natural snowfall or from biological/chemical processes within the snowpack. Water collected in the lysimeter on May 15th had a higher total nitrogen concentration than the runoff sample and core sample collected on April 24th which would be consistent with a slug of nutrients being washed out in the initial meltwater. The ammonia concentration in the runoff, 0.12 mg/l NH₃-N, was higher but consistent with average concentrations measured for the control samples (0.082 mg/l NH₃-N).

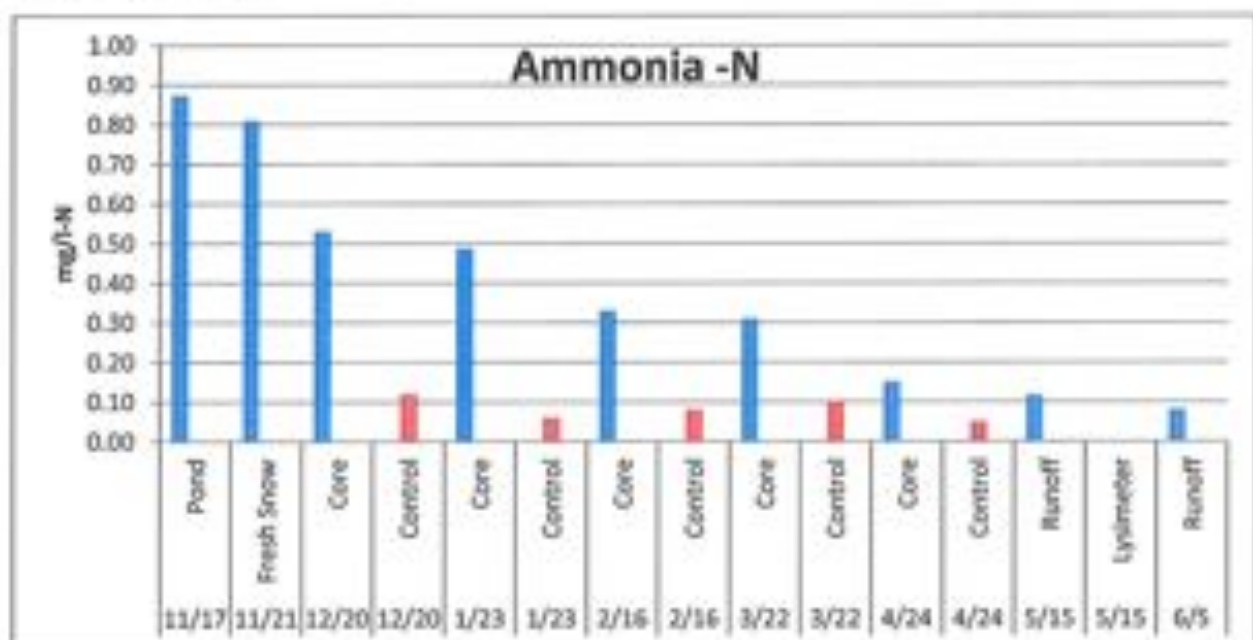
Ammonia ($\text{NH}_3\text{-N}$) also showed a significant decrease during the snowpack aging process. The ammonia concentration in the pond was 0.87 mg/l, which was reduced to 0.1 mg/l in the runoff water. Ammonia was not detected in the water collected in the lysimeter. Ammonium ($\text{NH}_4\text{-N}$) in the fresh snow had an average concentration of 0.43 mg/l which decreased to an average of 0.25 mg/l $\text{NH}_4\text{-N}$ in the March core sample and to non-detect levels in the April core samples and runoff samples.

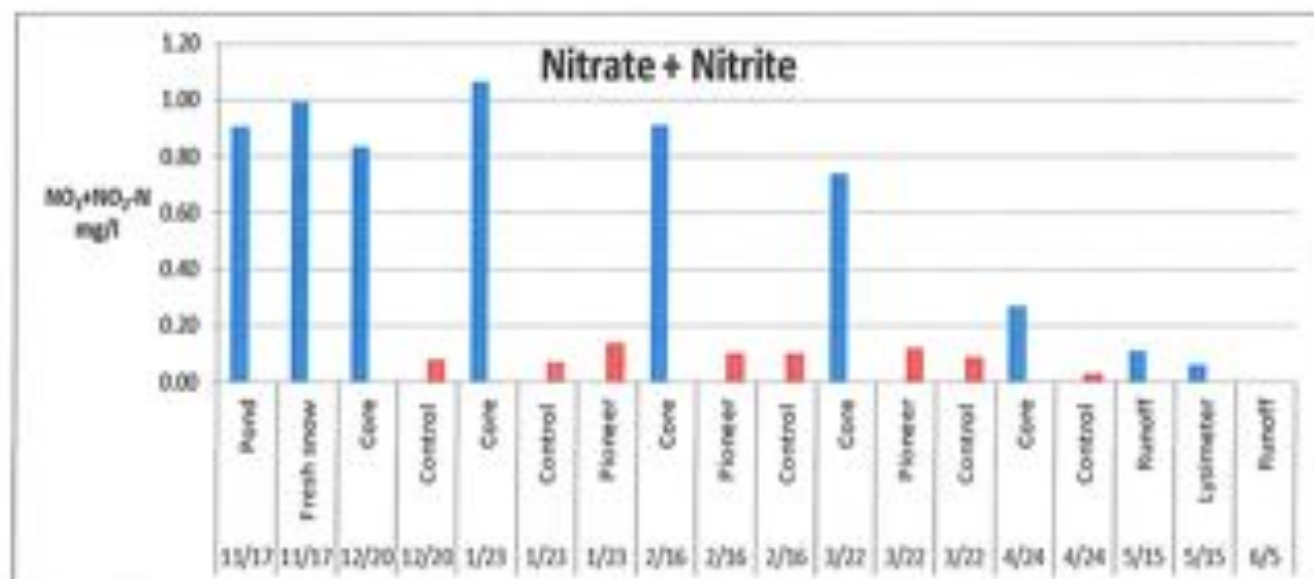
The concentration of nitrate + nitrite increased slightly after the snow was originally applied and then decreased to background / control levels during the runoff period.

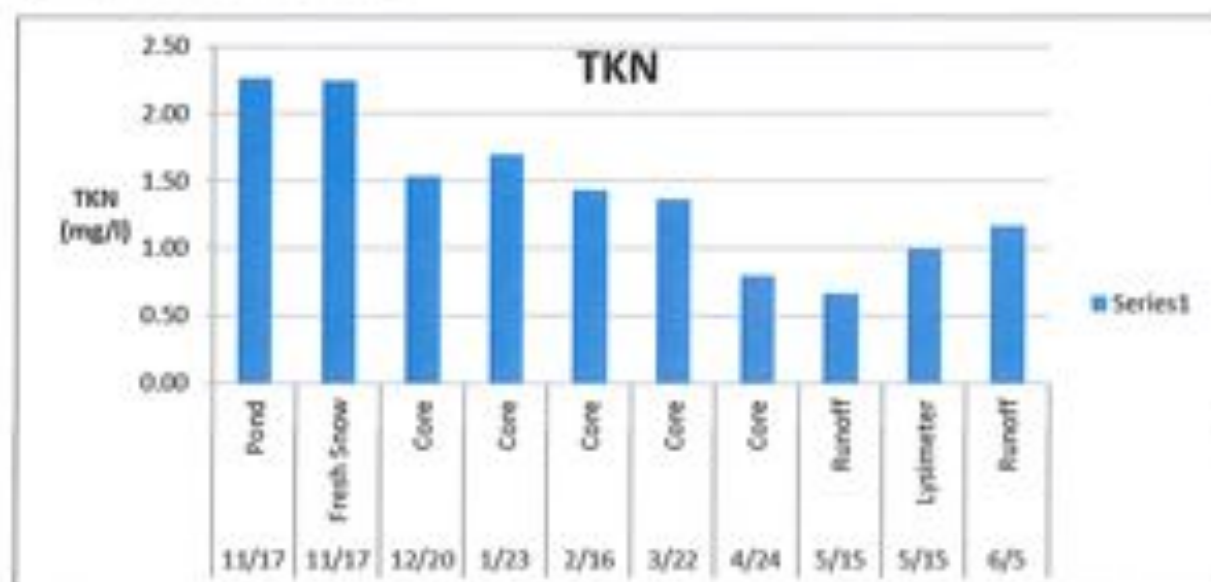
Total Kjeldahl Nitrogen (TKN), which is the sum of the organic nitrogen, ammonia, and ammonium, also decreased in concentration through the snow aging process from concentration of 2.3 mg/l in the pond to 0.67 mg/l in May. The concentration increased slightly in the lysimeter and the June runoff.

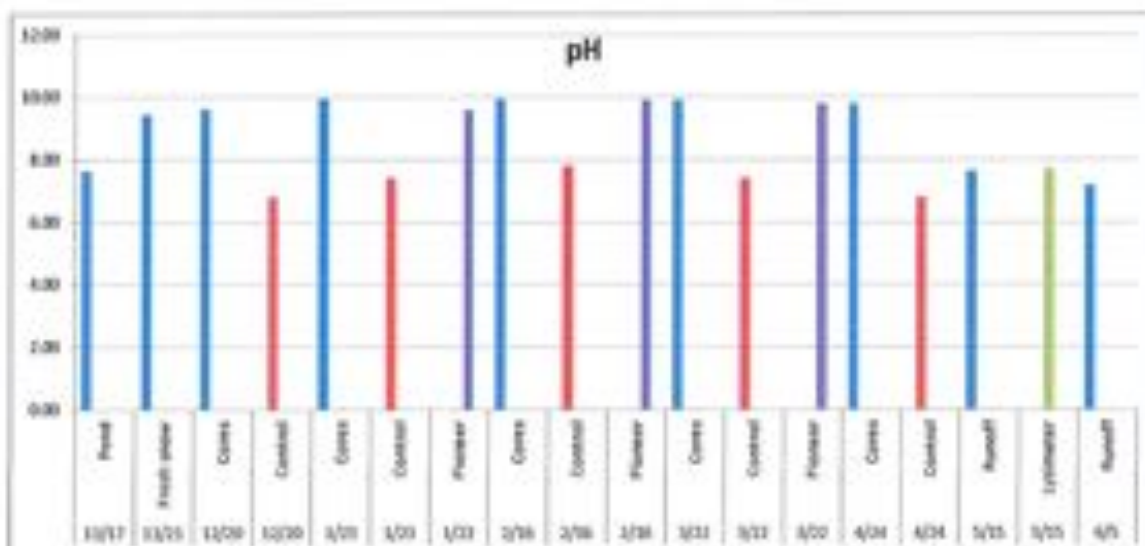
The pH of the water used in the snowmaking operation increased from 7.63 to 9.45 in the fresh snow and then remained in a range of 9.5 to 9.93 until May when the pH of the runoff was measured between 7.17 and 7.63. It is important to note that the shift in pH from 7.63 to 9.45 also drives the form of ammonia present to a higher percentage of gaseous NH_3 from the ammonium ion NH_4 which exists in aqueous solution. At a pH of 7.1 and a temperature of 1°C the percentage of total ammonia present in the NH_3 form is 0.113% whereas at a pH of 9.5 and 1°C the percentage of NH_3 is 22.1% (EPA, 1979)

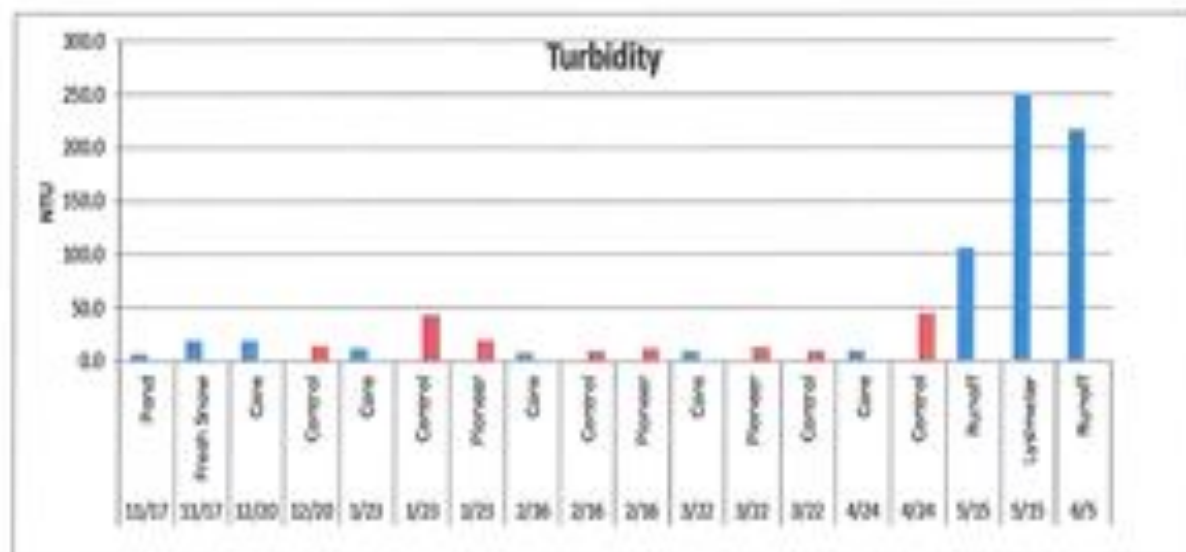
Turbidity levels were consistent with control values observed at the snowmaking site and on Pioneer Mountain. During spring runoff turbidity levels spiked as would be expected. The high turbidity observed in the lysimeter sample was most likely caused by washing fines out of the soil in the lysimeter.

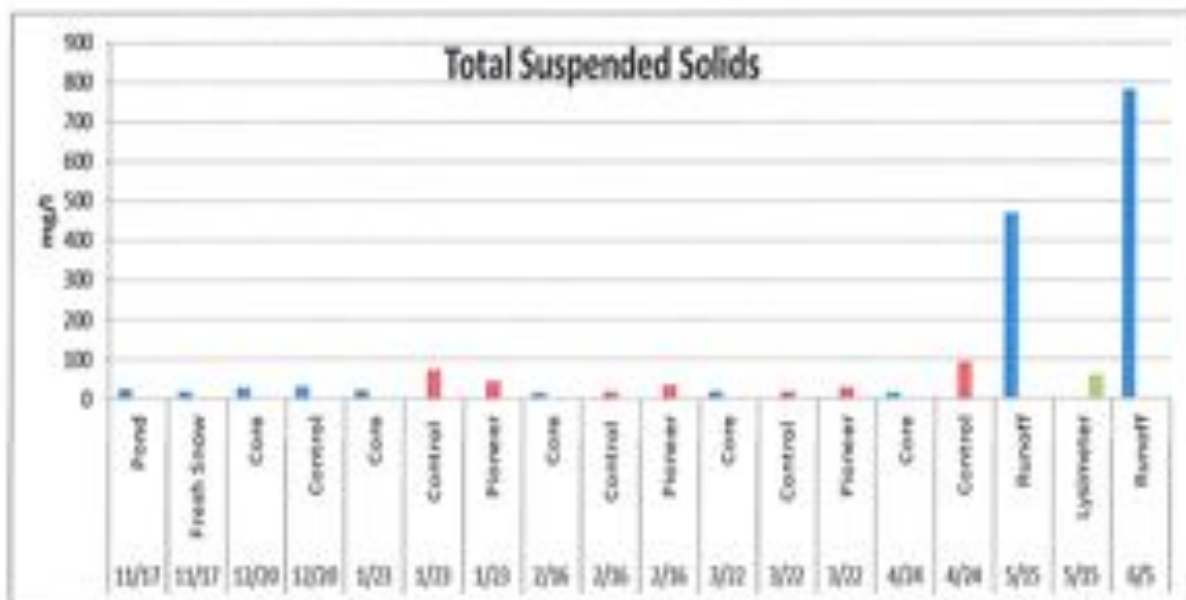
Total Suspended Solids concentrations in the pond and snowpack were consistent with the control site and the site on Pioneer Mountain. A spike was observed during spring runoff which is most likely caused by sediments picked-up from the soil during runoff.
