Taylor Fork of the Gallatin River 4B Water Quality Analysis Gallatin National Forest

October 25, 2007

Taylor Fork of the Gallatin River

4B Water Quality Analysis

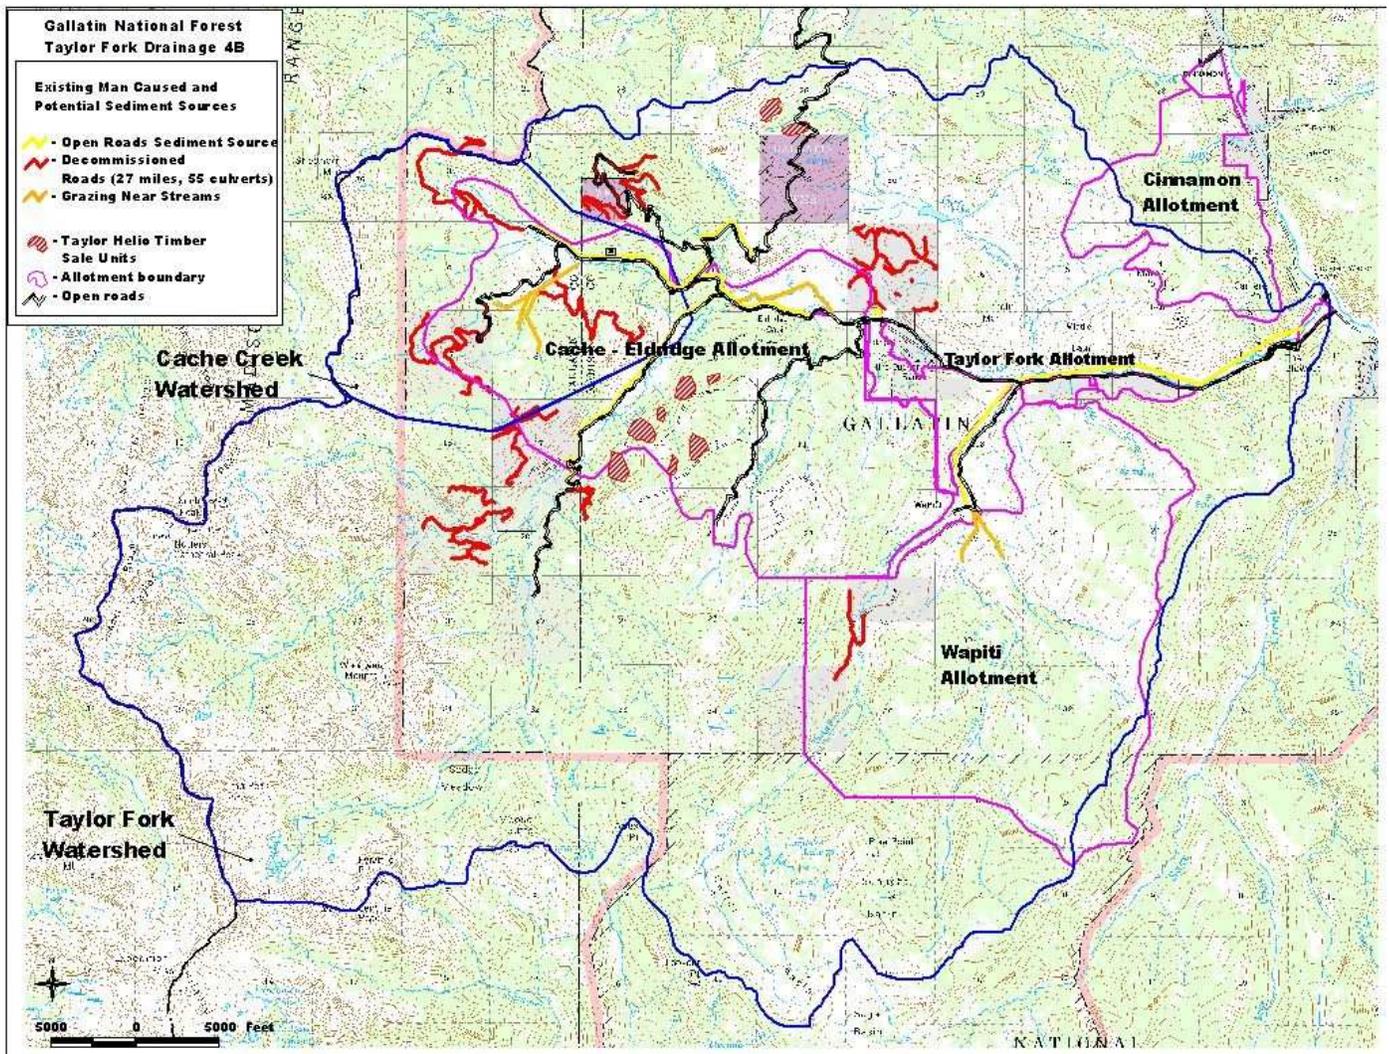
Figure 1. Taylor Fork Watershed (63,360 acres) with watershed boundaries, sediment sources, management activities, and completed restoration.

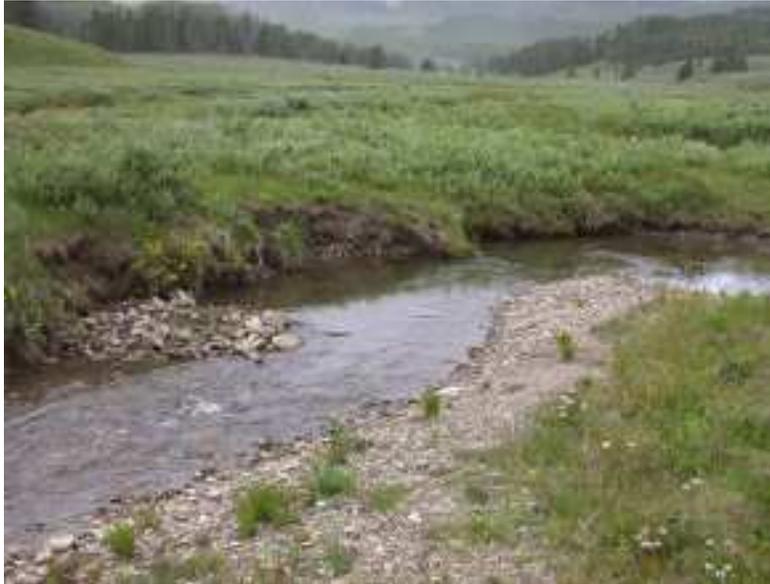
Photo 1. Impacted riverine wetland in the Cache-Eldridge Allotment, with streambank trampling and a relatively wide shallow channel. Fish numbers are 26/100 square meters within this reach and the % of fine sediment <2mm is 21%, which represents a fair condition. This rating is based on based on a combination of values found in scientific literature (Reiser and Bjornn, 1979) and professional judgement.

The Cache-Eldridge Allotment was approved in 2006 (USFS- Gallatin NF, 2006b) which eliminate the Cache Pasture and excluded livestock grazing from Cache Creek. The changes proposed under all of the alternatives are designed to improve stream conditions and are a normal component of BMP upgrades. Some of these sections in 2003, particularly the East Fork of Cache Creek and the South Fork of the East Fork had destabilized streambanks from livestock grazing and bank trampling that acted as sediment sources during high streamflow periods. These sections were not been grazed by livestock in 2004 and 2005 and were be closed to livestock grazing in the Cache-Eldridge AMP revision in 2006.

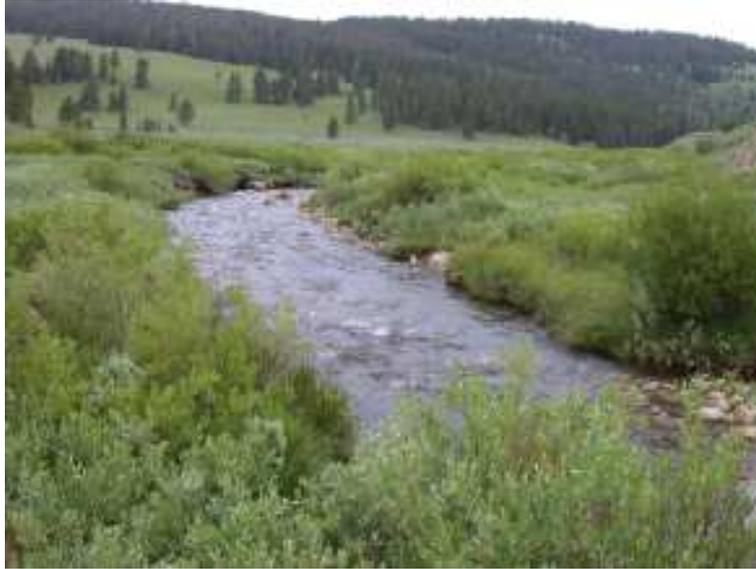
Photo 2. Little Wapiti Creek, Wapiti Allotment. Note the healthy riparian vegetation and stable banks. This stream is a Rosgen (1996) C3b channel type with a good channel stability rating and in proper functioning condition. (August, 04).

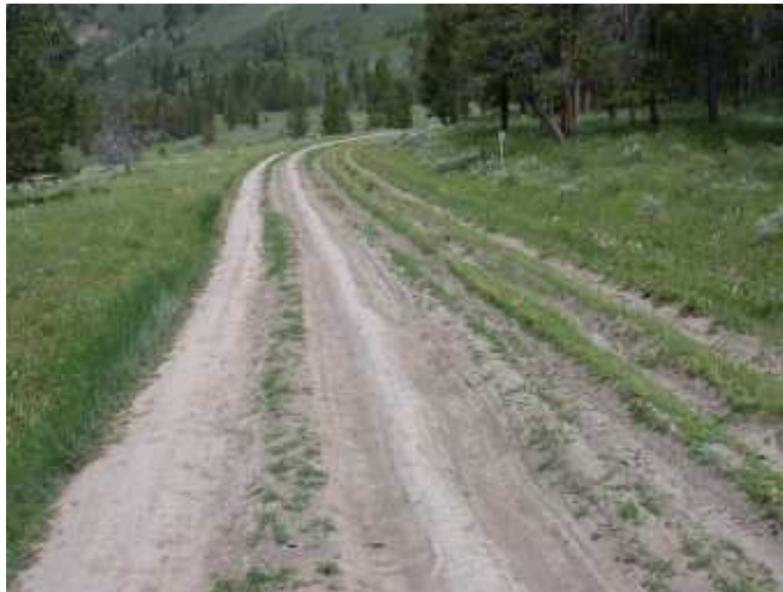
Photo 3. Cache Creek Road Identified for Gravel Surfacing in 2006.

The most significant road related sources of sediment are the un-surfaced roads in the upper ends of the Taylor Fork and the Cache Creek watersheds. The Cretaceous sediment geology found in this area is not well suited for un-surfaced, native material roads, because it is easily eroded.

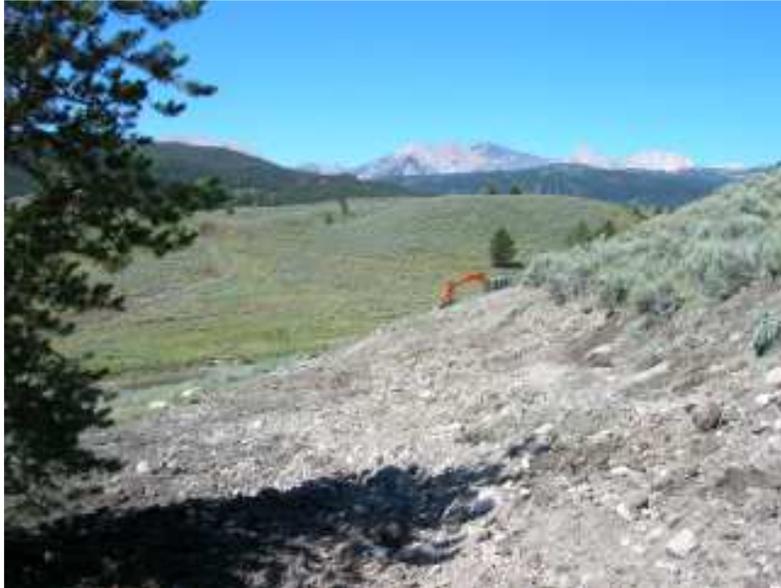
Photo 4 . Re-contoured road in T9S R3E S1. Treatment consisted of pulling fill slopes and packing back in the road prism to cover the cut slopes. Topsoil was placed on the surface as much as possible. The re-contoured road prisms were then seeded and hydro-mulched. The upper left part of the picture is a road segment to a former cabin which was ripped, drained, and seeded (Photo taken on 7/27/05).

National Forest. Access roads to the Section 1 cabins were decommissioned (re-contoured and hydro-mulched or ripped, drained, and seeded) in July/August of 2005.

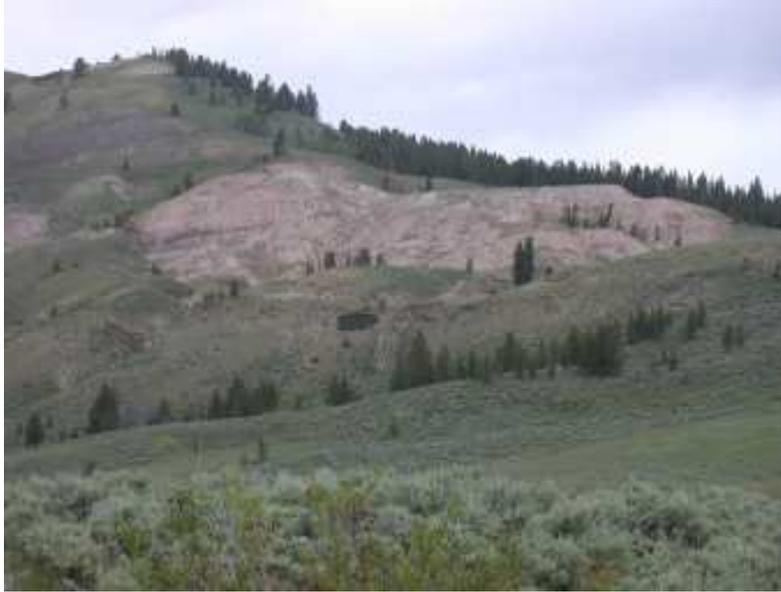
Photo 5. Lower Taylor Fork Cretaceous sediments.

Cretaceous sediments found extensively in the Taylor Fork watershed are the primary source of sediment in the drainage. The western two-thirds of the Taylor Fork watershed and virtually the entire Cache Creek drainage have Cretaceous sediment parent material. During snowmelt runoff and particularly from high intensity rain events the Cretaceous sediments, which are high in clay content, can turn Taylor Fork and even the entire Gallatin River turbid for a few hours. The highest concentration of Cretaceous sediments occurs in Cement Creek where over 300 acres of “badlands” are present. These have little vegetative cover and are comprised of Meade Peak (Albino) Shale. This area erodes easily and yields large amounts of fine sediments as a result of active rill and gully cutting. Salts, iron, phosphate, and selenium are found in these fine sediments. While these contributions may adversely impact aquatic biota, they are naturally occurring, so no treatments are planned to reduce sediment yield from this area.

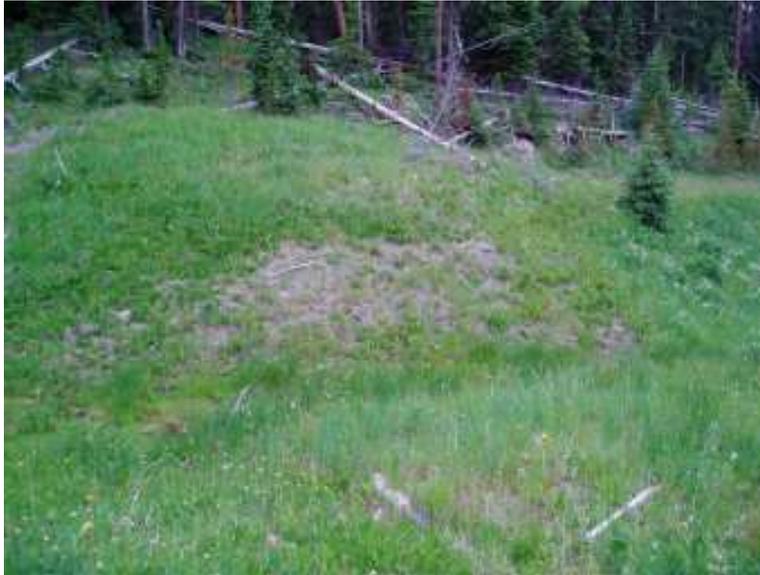
Photo 6. The East Fork of Cache Creek Road was decommissioned in 2002. The culverts were removed, slopes laid back, and the area seeded. The site is completely recovered and the road tread does not have any rill erosion evident.

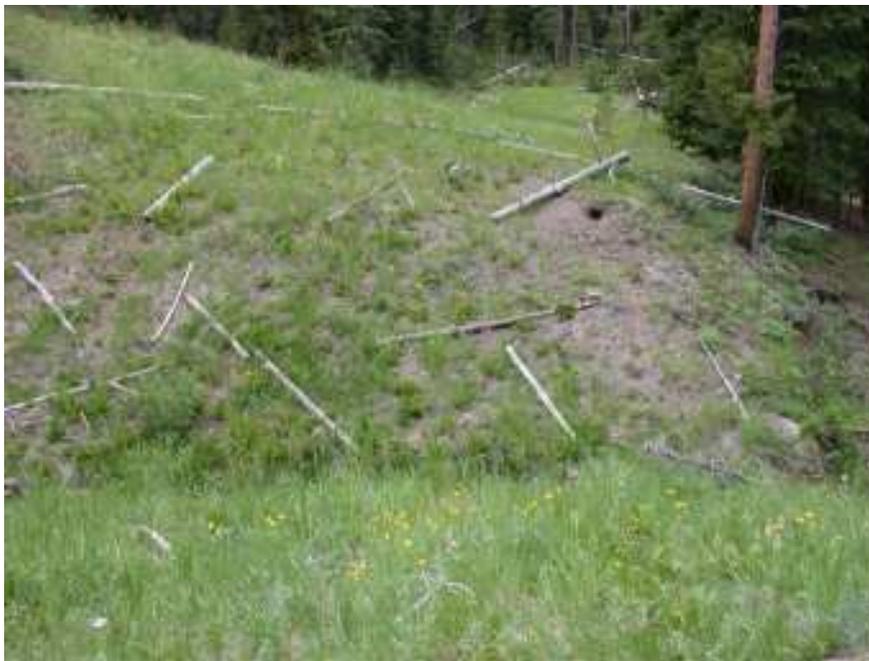
Photo 7. East Fork FK Cache Ck Road. The road surface was ripped, seeded, and drained. Logs were placed on cutbank slope to catch sediment and stabilize the slope.

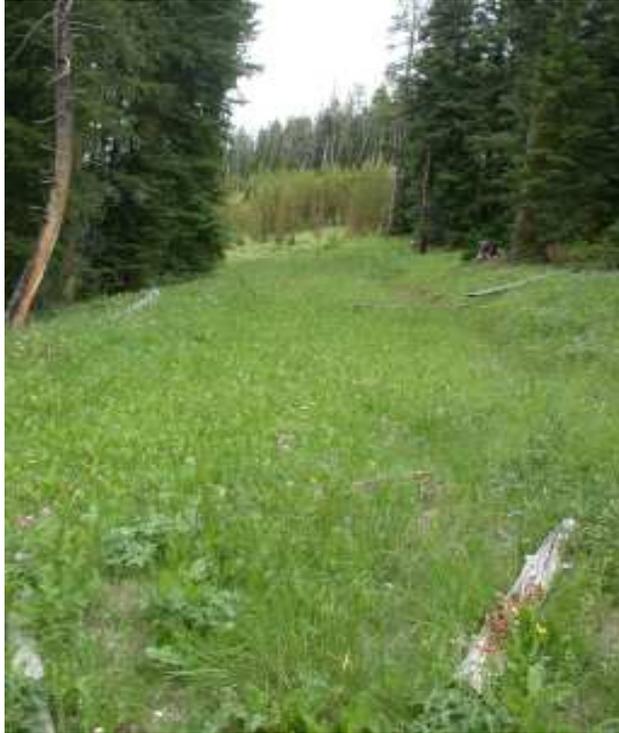
Photo 8. East Fork Cache Creek Cache Ck Road. Seeded and Stabilized Road. This road section is typical of most of the decommissioned road segments in Cache Creek. Note lodgepole regeneration in historical timber harvest unit in the distance. Both the road and timber harvest unit in this area are no longer sediment sources to Cache Creek.

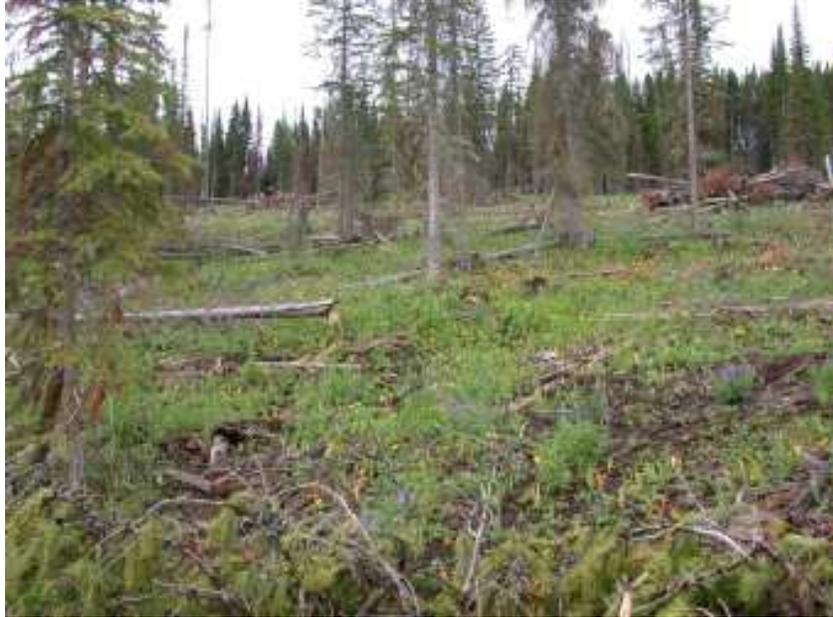
Photo 9. Taylor Helio Unit # 113 (2004) two years post harvest.

Timber harvest in the Taylor Helio Sale is completed, and provides good evidence of the effectiveness of the BMPs implemented. All of the tractor units are completed and the work accepted by the Timber Sale Administrator. Helicopter units were completed in December 2004. All sale closure activities (site preparation, grapple pile cleanup, and landing pile burn and top soiling) were completed by 8/05 when the sale contract terminated. Photo 9 was taken in Unit 113 which was harvested in the fall of 2002. The unit has been closed and accepted. There is no evidence of overland movement of sediment.

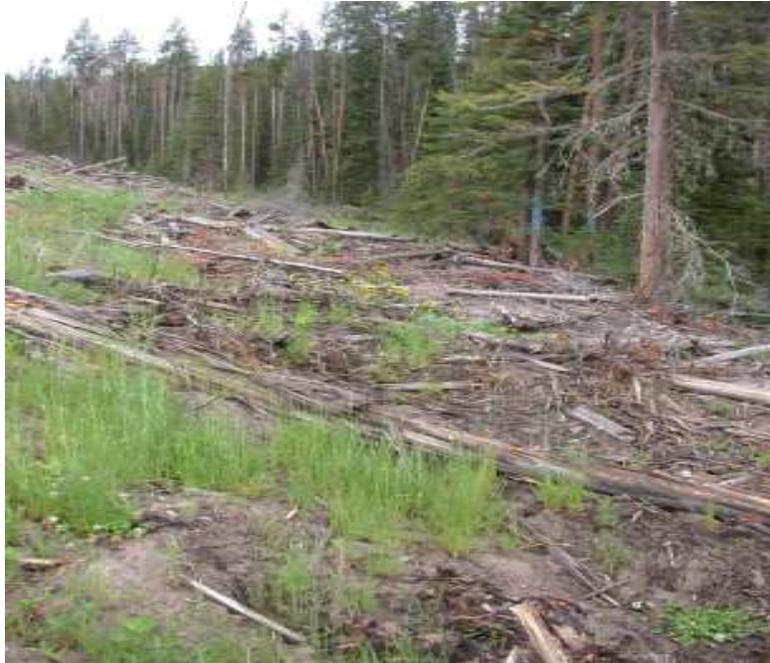
Photo 10. Slashed Skid Trail in Taylor Helio Sale. The skid trail was ripped, seeded, then slashed. The treatment is designed to eliminate erosion potential and protect soils.

The skid trail in Photo 10 was slashed after the unit was completed. Skid trail rehabilitation was implemented throughout the Taylor Helio Sale with similar results of no soil displacement.

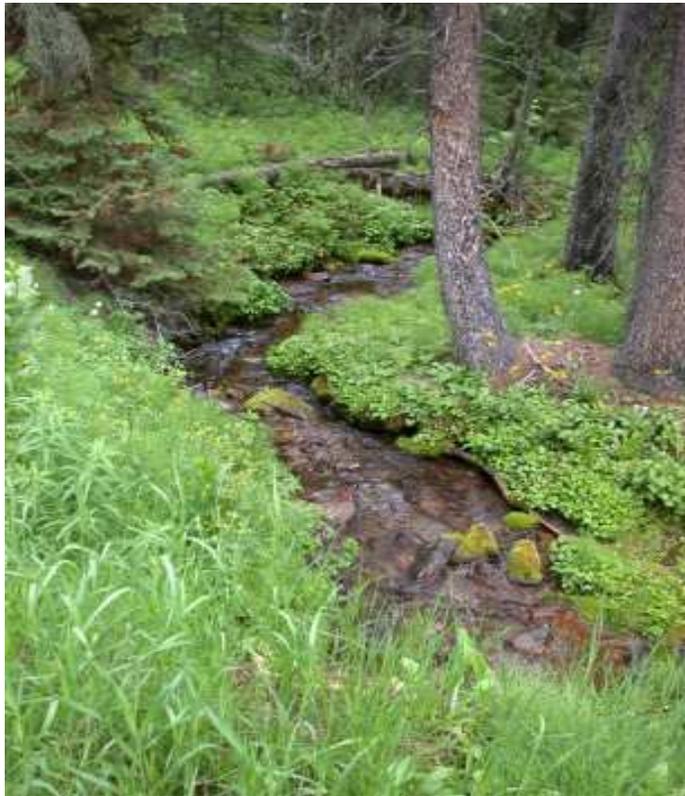
Photo 10. North Fork of Deadhorse Creek 50 feet below Unit 113 of the Taylor Fork Helio Sale. There is no evidence of sediment entering the channel, indicating that the BMPs were effective.

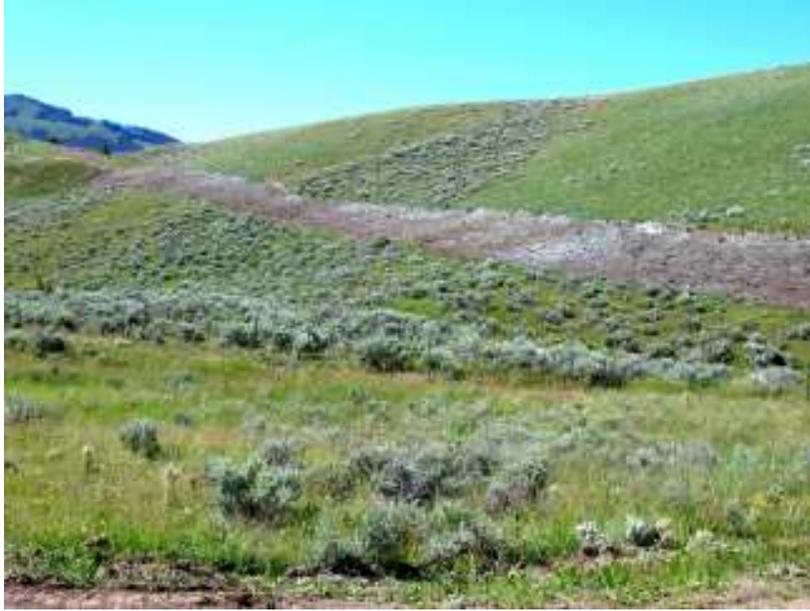
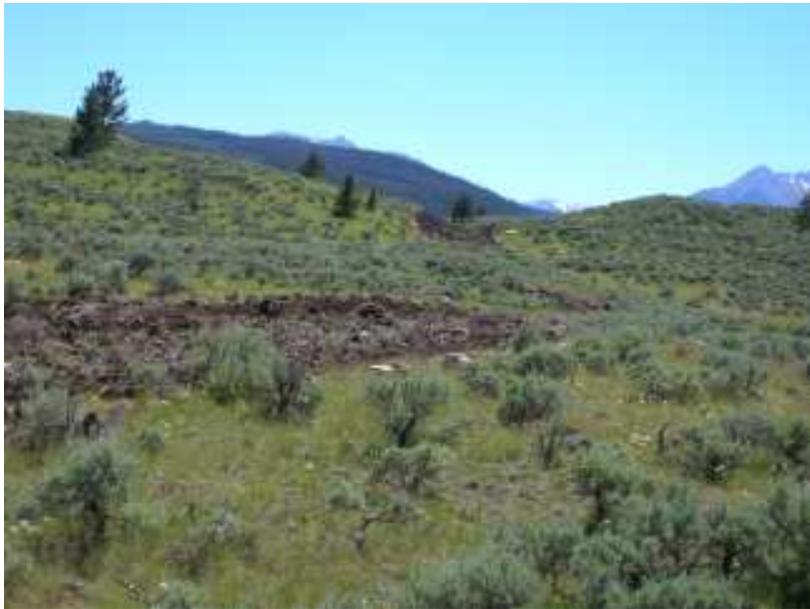
Photos 11 and 12 Decommissioned Roads - Both of these photos were taken in 8/05 in T9S R3E S1 in the rehabilitation of lands acquired by the Gallatin NF. The upper photo is a re-contoured road section after hydro-mulching. The lower photo is a ripped, drained, and seeded road segment to a former cabin site (removed in 9/04). Re-contouring was done with a small excavator for road segments with large cut and fill slopes. The rip, drain, and seed treatment was used on road segments with small enough of cut and fill slopes to be restored with a dozer.

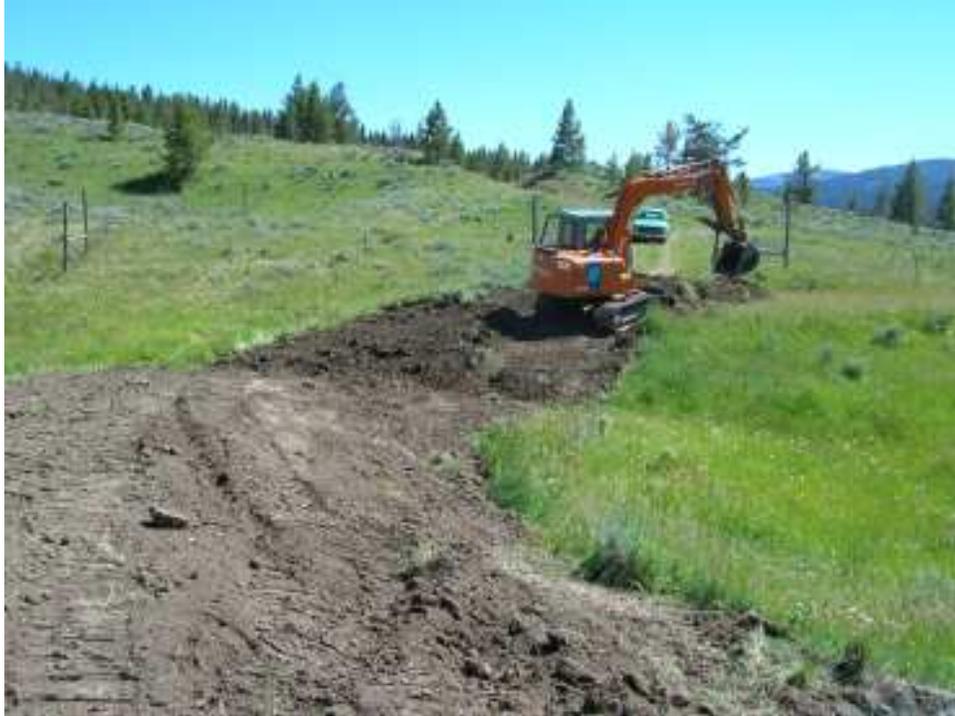
Photo 13. Decommissioning - This photo in T9S R3E S1 was taken on 7/27/05. A culvert was removed and stream banks restored to pre-road channel geometry. The area was then seeded and hydro mulched. Revegetation response is expected to be robust. The treatment is designed to eliminate the road as sediment source and avoid a long term potential sediment source if the culvert fails. The road decommissioning work on Gallatin NF lands during 2002-2005 has removed 55 culverts in the Taylor Fork watershed.
